ANNUAL REPORT  
OF THE  
ARCHÆOLOGICAL SURVEY  
OF INDIA

1923-24

SIR JOHN MARSHALL, Kt., C.I.E., M.A., LITT. D., F.S.A., HON. A.R.I.B.A., HON. PH. D.;  
*Director General of Archaeology in India.*

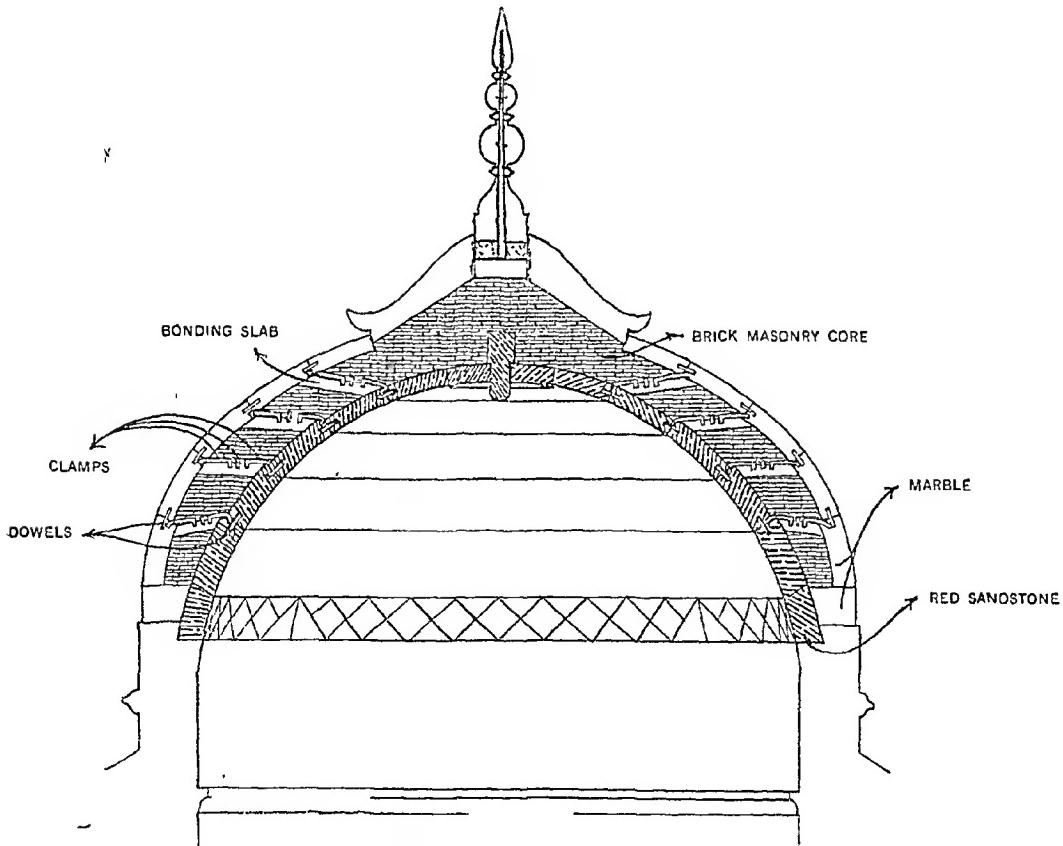
FIG. 1.

annual repairs. At Agra, the chief work was the rebuilding of the south-west United corner chhatri at the Taj. On account of cracks in its dome and the breaking Provinces of most of the lintels, brackets, capitals and bases of pillars as a result of the sinking of its plinth, the whole of the chhatri was in a precarious condition. As a temporary measure, three of its openings had been filled in with brick <sup>Agra</sup> masonry walls to support the most affected parts (Pl. I,a), until funds could be made available to rebuild it. In the reconstruction every care has been taken to re-use as far as possible the old serviceable stones, and with this object all the stones were numbered and photographed before dismantling (Pl. I,b). The work of dismantling and lowering the heavy stones from a height of some 80 feet was not without difficulty and danger, requiring a heavy scaffolding (Pl. I,c), strong ropes and pully blocks and the task was made all the more complex owing to the extreme care that had to be taken to avoid damage in the removal of the stones. In the course of dismantling it was found that the cupola of the chhatri was not constructed on the usual dome principles. Instead, it was built as a solid mass with exterior and interior facings of marble and red sandstone respectively, the interspace between these facings being filled in with a brick masonry core. The facing stones were held in position with iron clamps and dowels, while bonding slabs fixed with iron clamps held together their respective inner and outer courses (see fig. 1).

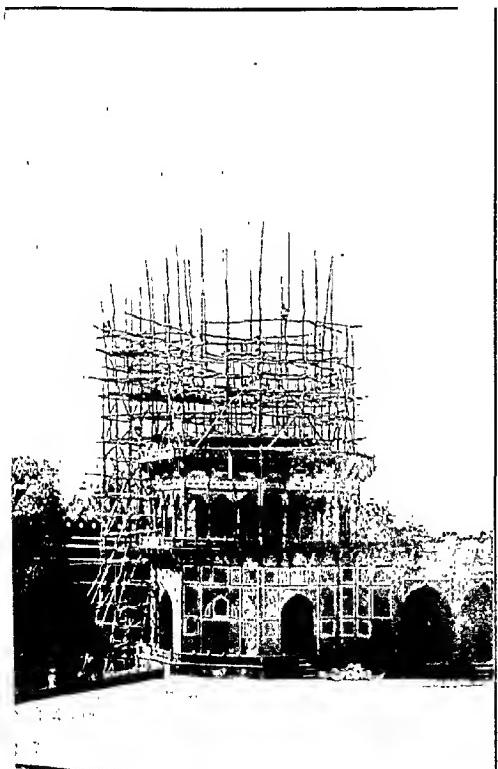
(a) SOUTH-WEST CHATTRI AT THE TAJ, AGRA, BEFORE  
CONSERVATION.

(b) SOUTH-WEST CHATTRI AT THE TAJ, AGRA, SHOWING NUMBERING OF  
MARBLE SLABS BEFORE DISMANTLING.

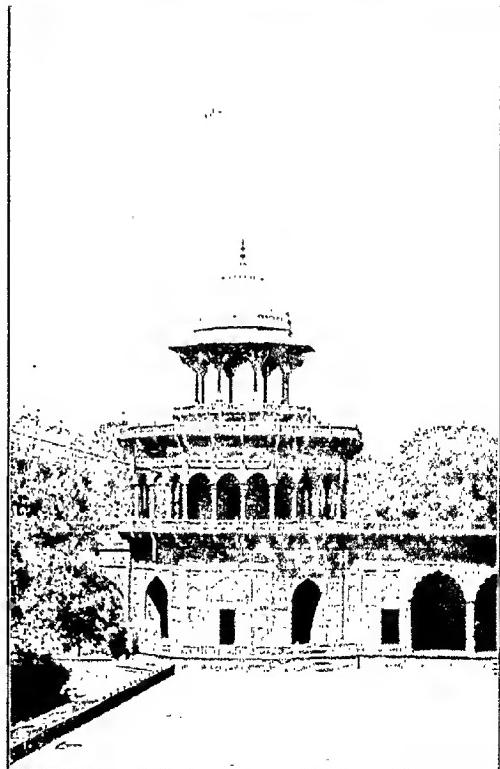
(c) SOUTH-WEST CHATTRI AT THE TAJ, AGRA, AFTER DISMANTLING.

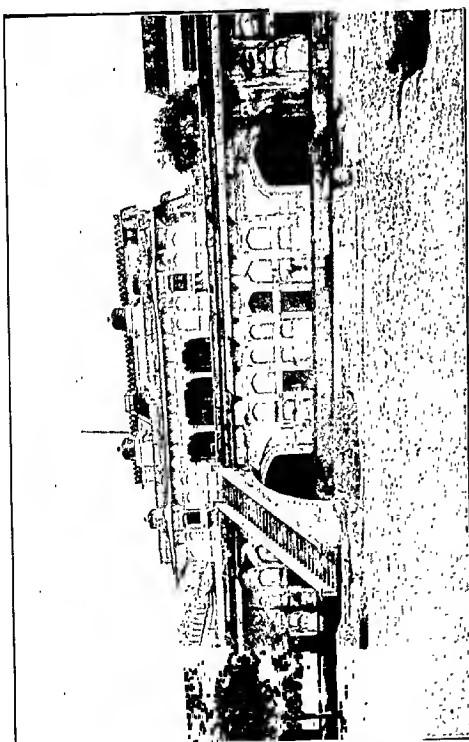
(b) SHAH ALAM KAUAZ, AHMADABAD DISTRICT: VIEW SHOWING REPAIRS TO DOMES OF THE MASJID INSIDE THE COMPOUND.

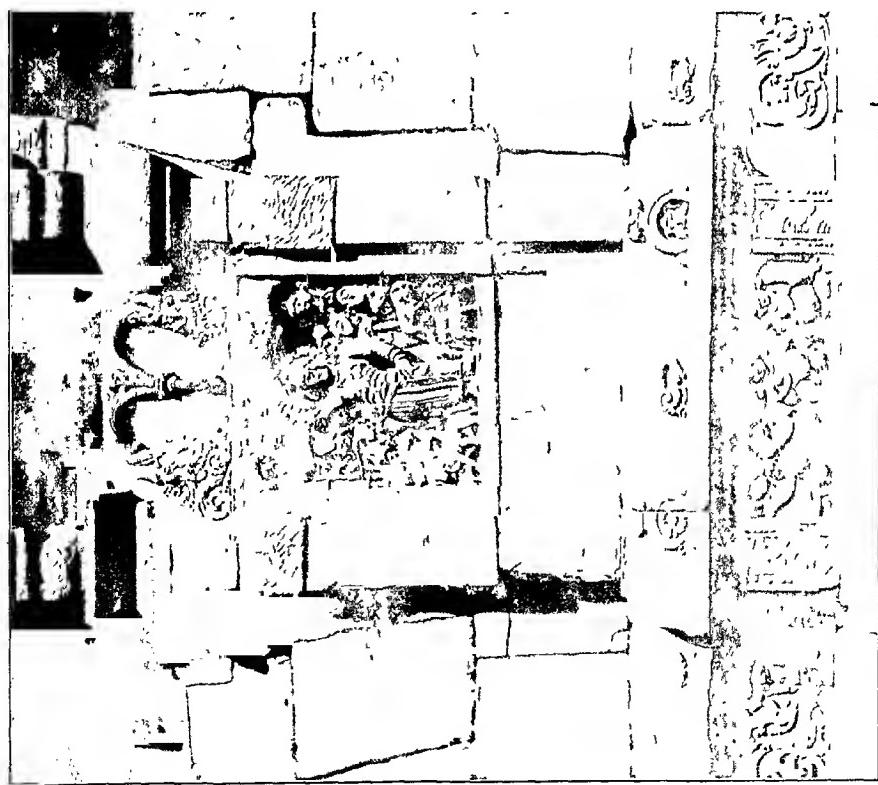
(b) Hampi Ruins : South-east tower in Zanana enclosure, after repairs.

(b) HAMPI RUINS. SOUTH EAST TOWER IN ZI NAYA ENCLOSURE, AFTER RAJARAO

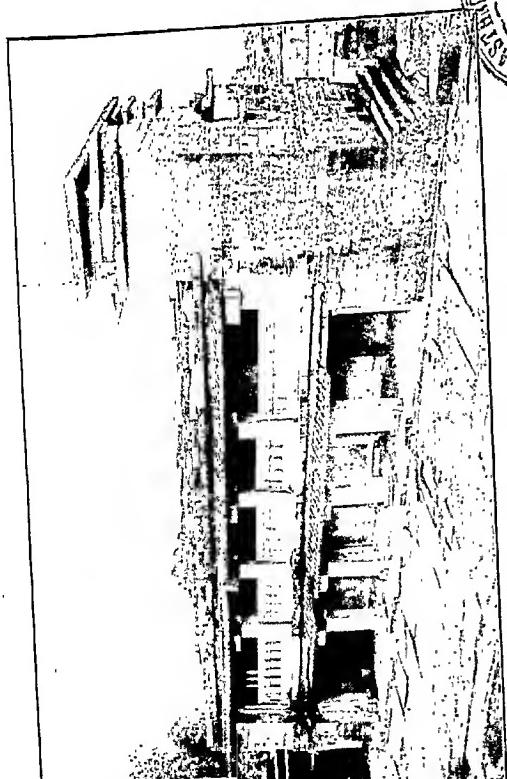
(b) PRABHAVATI JAIN TEMPLE AT RANOD; GENERAL VIEW FROM NORTH-EAST,  
AFTER REPAIR.
